(6) National Dam Inspection Program.
LAKE HENRY DAM
Number
(NDI ID ~~PA-00366~~
DER ID ~~35-16~~),
Number.
~~PENNSYLVANIA GAS AND WATER COMPANY~~
Susquehanna River Basin, Lake Run,
Lackawanna County, Pennsylvania.
PHASE I INSPECTION REPORT

LAKE HENRY DAM

NDI ID No. PA-00366
DER ID No. 35-16

PHASE I INSPECTION REPORT
NATIONAL DAM INSPECTION PROGRAM

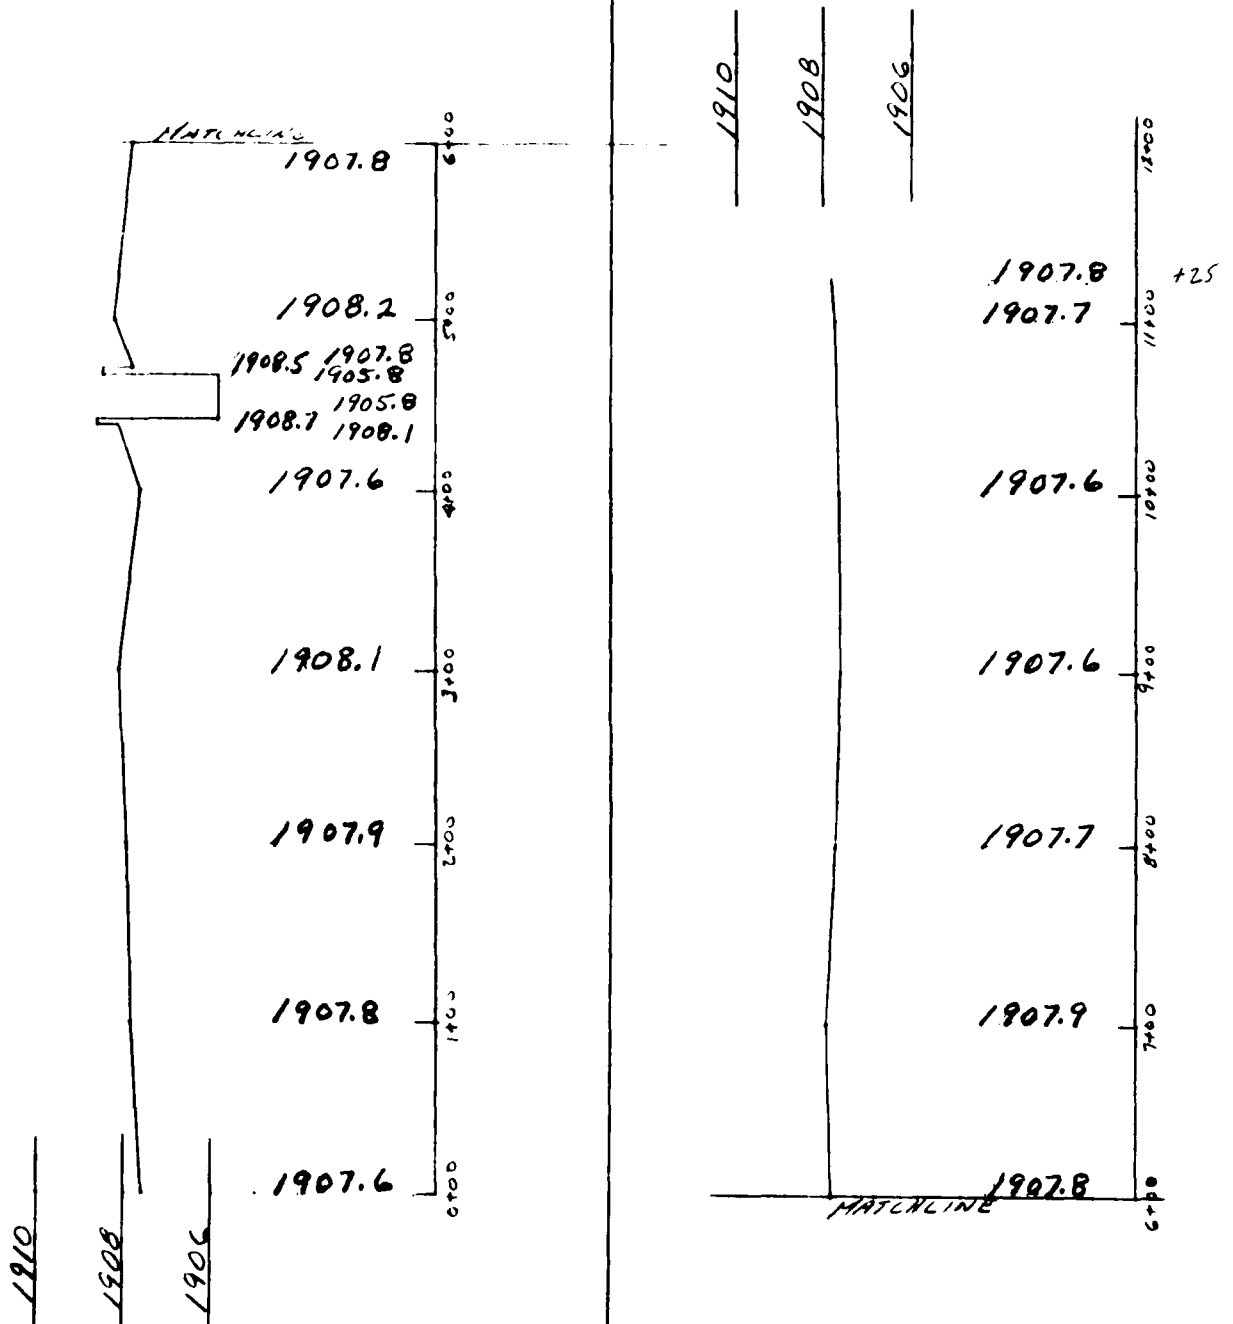
RIGHT EMBANKMENT - PROFILE

b. Embankments. Both embankments are thickly covered by ferns. The caretaker of the dam reported that this was a normal summer's growth. The brush had been cut the previous spring. Trees are growing at the toes of both embankments. The riprap on both embankments only extends up to the spillway crest. The riprap is in good condition. The tops of both embankments have low areas. The low areas extend over most of the tops of both embankments. The lowest point on the right embankment is 0.7 foot below the design top elevation; the lowest point on the left embankment is 0.6 foot below the design top elevation. The existing profiles are shown in Appendix B.
